Hygrothermal Failure Case Study: Fergusson School

Data were collected from a failed roof system for a school in Wellington, New Zealand. The failed roof consisted of a metal sheeting fixed to steel purlins over a small plenum that had a high level of insulation placed over a removable insulated ceiling tile. The information collected was used in a hygrothermal model to extract the boundary conditions needed to replicate the observed failure. This was done to understand hygrothermally why the failure occurred and to calibrate the boundary conditions used in the existing model for future analysis.

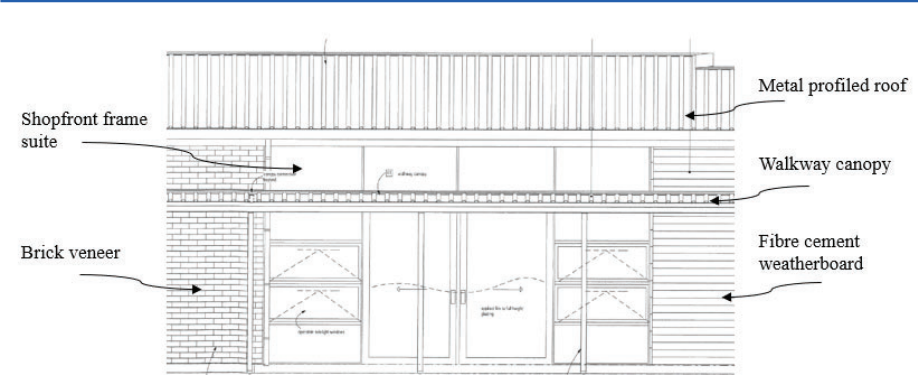
FIGURE 1. General construction of the building enclosure.

The building that is the subject of this paper was situated in Upper Hutt, Wellington, New Zealand. The building was north facing, situated in climate zone 4,¹ corrosion zone 2,¹² and at an altitude of 49 m [161 ft] above sea level. The building was lightweight construction with timber framing, brick veneer, and a metal skin roof (Fig. 1). Internally, the walls were lined with plasterboard and had a suspended tile ceiling.

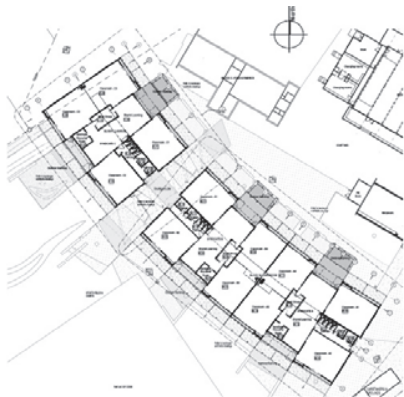
FIGURE 2. General layout of the classrooms.

The building is composed of 10 main rooms, which are a combination of classrooms, common areas, and changing rooms (Fig. 2). The classrooms were approximately 9.5 m × 7.5 m [31 ft × 25 ft] in floor area and 2.4 m high [8 ft].

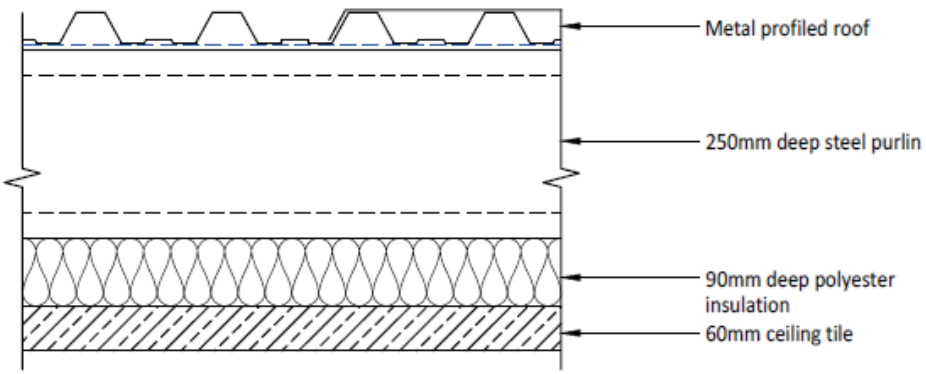
FIGURE 3. Roof/ceiling assembly.

The roof and ceiling were constructed as shown in Fig. 3. The main components were acoustic tile, ceiling insulation, plenum with steel purlins at approximately 1,200 mm [4 ft] centers, wire netting, underlay, and a metal profiled roof.

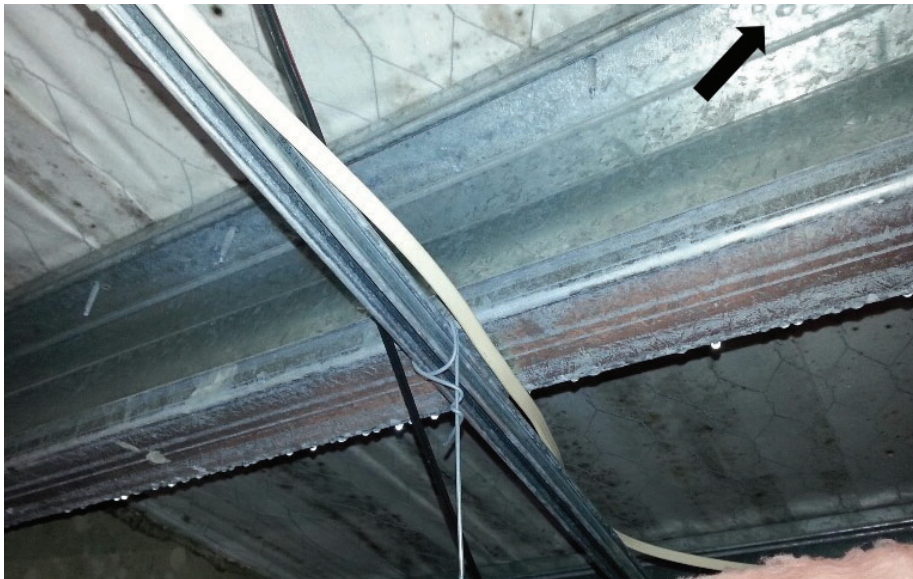
FIGURE 4. Condensate forming on purlins.

Shortly after the completion of the building in the winter months, condensate was noted forming on the steel purlins in all of the class-rooms (Fig. 4). There were also signs of organic matter growing on the building wrap (Fig. 5). It is expected, based on previous investigation by the authors, that the black growth is *Stachybotrys chartarum*, a common mold found in New Zealand (and elsewhere in the world) in building enclosure layers.

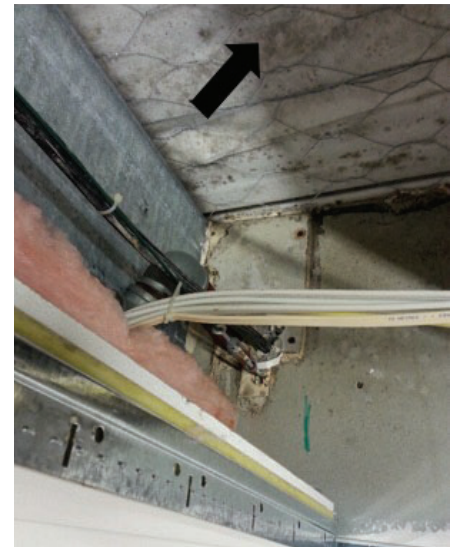
FIGURE 5. Visible organic growth on the building wrap.

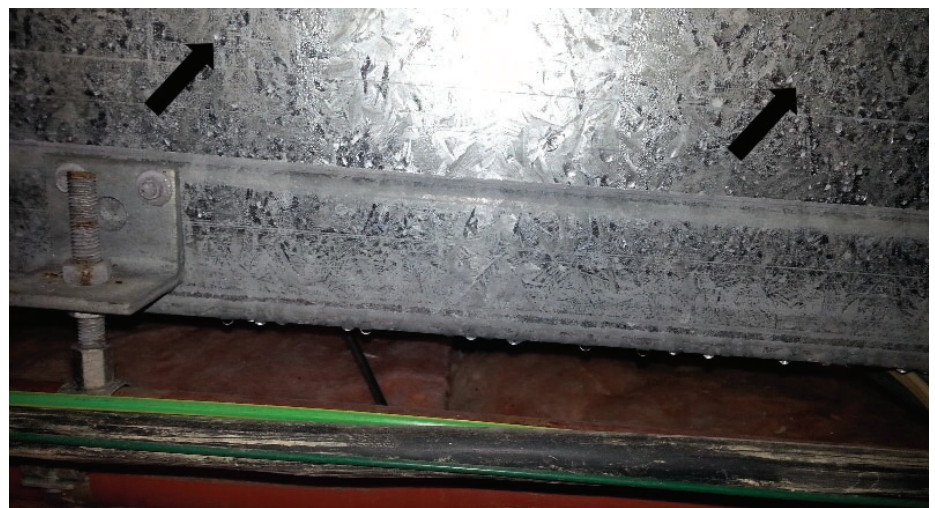
It was estimated that the condensate drops were greater than 150 g/m^2 [0.031 lbs/ft^2] as it was apparent that runoff occurred from this upper region and manifested in drops on the lower edge of the purlin (Fig. 6). It was also noticed that the pipe support bolt and nut showed signs of corrosion, which is a sign of high moisture load occurring in the plenum. Table 2 replicates a guide on droplet density and its implications from EN ISO 13788.

FIGURE 6. Droplet formation on the steel purlin and rust evident on services bolt and nut.

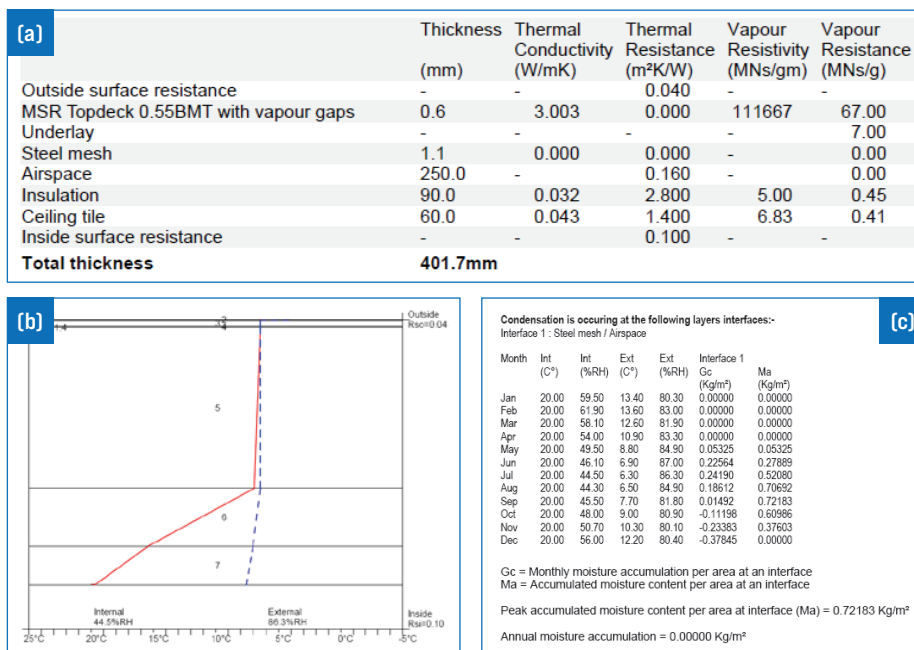
FIGURE 7. Condensation analysis of a traditional roof: (a) roof buildup; (b) solid line representing the interface temperature and the dotted line the corresponding dew point temperature; (c) condensate peak and annual accumulation values.

The results for the winter analysis (the time of the year when the problem occurred) for the failed traditional roof are shown in Fig 7. In the graph shown in Fig. 7b, the solid line (interface temperature) and dotted line (corresponding dew point temperature) touch at the interface between the plenum and the mesh/airspace layers. The predicted moisture and accumulation are shown in Fig. 7c. The modeling indicates that condensate occurs from May through to December before the drying potential of the system starts in the summer months. The model predicts that a significant amount of condensate would occur and would form droplets of water that would drip from a horizontal surface (i.e., the upright face of the purlin), which correlates well with the observations.

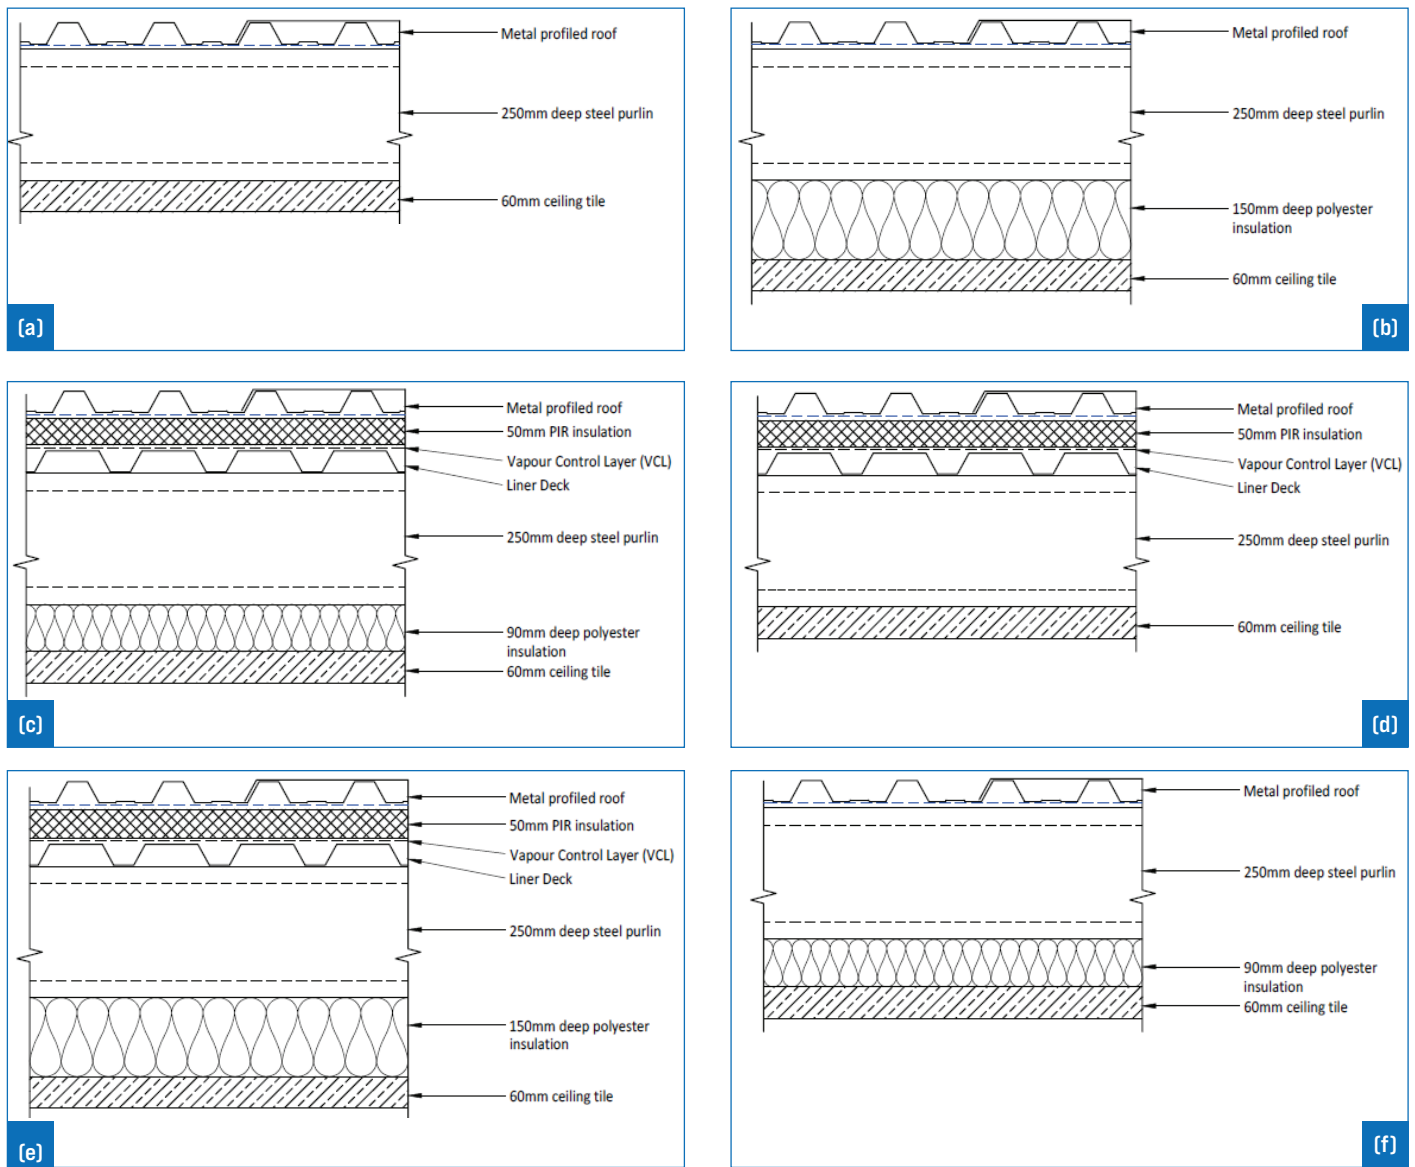
Depictions of each of the scenarios are shown in Fig. 8.

FIGURE 8. Modeled scenario sections: **(a)** No extra insulation directly above the insulated ceiling tile in a traditional roof; **(b)** More insulation in a traditional roof; **(c)** An insulated roof with the original failed roof setup; **(d)** Less insulation in the ceiling plenum with an insulated roof; **(e)** More insulation in the ceiling plenum with an insulated roof; **(f)** original case including safety factors.
